Vermont Rivers and Roads Training Program

River Modeling Exercises

Appendix A: Disaster Scenario Plans Profile and Cross Sections

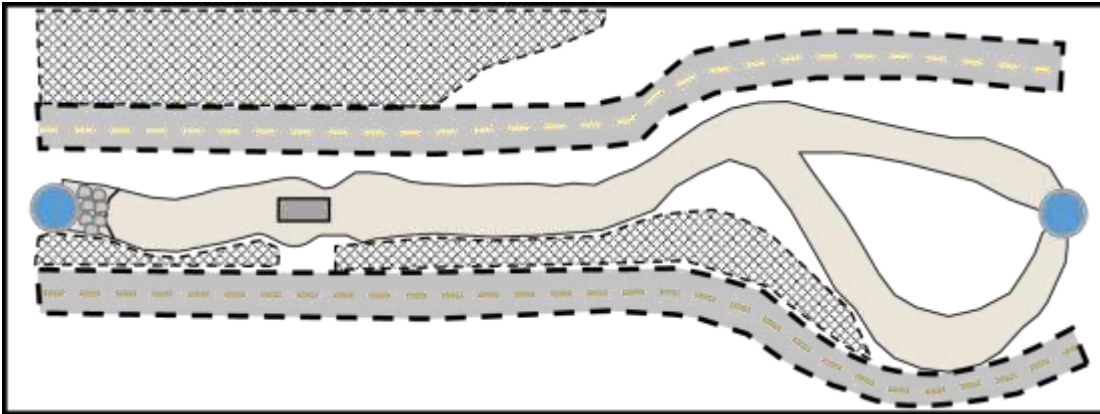
Figure 1. Planview of river model showing general valley and river morphology and road layout. Hatched areas represent terraces.

Set the base of the energy dissipater at the upper end of the model tray as normal and at a height of 3 inches above the tray bottom. Use netting fabric and ¾-inch stones to build a secondary energy dissipater at the outfall of the primary dissipater as shown in figures 1,2 and 3 of Appendix A. Set the stand-pipe to a height of 2 inches above the tray bottom.

Referring to Figures 1, 2 and 3 of Appendix A, establish the general valley and pre-flood channel morphologies along the length of the tray. Take care to create floodplain and terrace features with sharp corners to make it easier for participants to identify and distinguish between features. Keeping the media sufficiently moist to create particle cohesion and using the carving tool helps in creating sharp feature corners. Create a narrow valley with an entrenched and steep channel along the upper third of the tray. Transition the channel to be slightly entrenched and moderately steep within a moderately confined valley along the middle third of the tray. Within the lower third of the tray create a broad valley with an un-entrenched meandering channel and a flood created avulsion channel. Make the channel 4-inches wide and 1-inch deep. Locate roadways and the culvert as shown in the figures contained

in Appendix A. Use a circular tube that is 2-inches in diameter to represent an undersized culvert (50% of channel width). Buildings should be placed along the side of the road opposite the river to establish that the road cannot be moved.

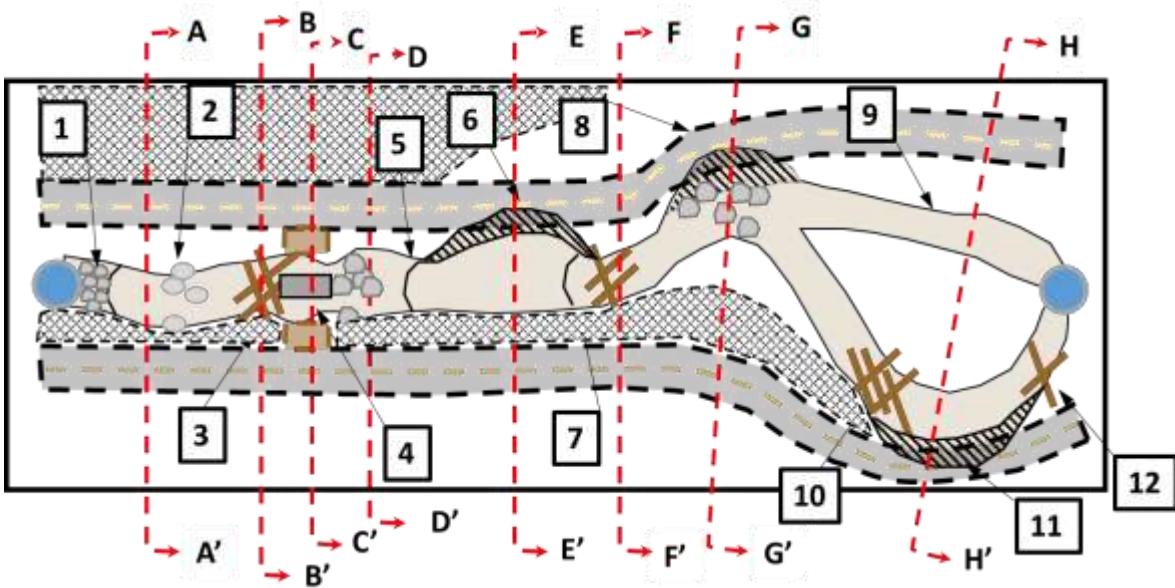
Figure 2. Planview of river model showing cross section locations and scenario features.

The 12 primary features included in the scenario are presented in figure XX. These features represent infrastructure failures and channel adjustments that must be addressed in the recovery design. These features may also provide diagnostic information that supports river process analysis and recovery design. Each feature and its construction are described below and possible solutions for addressing them are presented.

- 1: Energy Dissipater: The purpose of the energy dissipater is to prevent outfall scour and maintain the upstream grade of the channel and prevent flow from going sub-surface. It is constructed by digging a basin that is approximately 4 inches in diameter and 2 inches deep, lining it with geotextile and covering with $\frac{1}{4}$ to $\frac{1}{2}$ inch stone.

- 2: Partially Failed Step Feature: The step feature is intended to indicate that the reach within the upper third of the flume is a step-pool Bedform. Participants should use the presence of the step-pool feature to support their selection of recovery practices (i.e. rock weir grade control). The step should be identified as a feature to be restored and may be used as an indication of appropriate excavation depth. Setup of the step feature is straight forward. Use a size stone that allows for 5 – 6 stones to span the bankfull channel. The step feature should be partially buried by flood deposits during setup to provide a reminder to participants that deposition excavation should be done carefully so as not to disturb boundary features that remained intact through the flood.

- 3: Aggraded bedload and woody debris clogging culvert: Participants will recognize that the deposited bedload and woody debris should be removed during the recovery operation. Discuss the appropriate width and depth to which the channel should be dredged before the material is excavated. A bankfull bench at this section provides a benchmark for measuring appropriate channel dimensions.

- 4: Undersized Culvert: The culvert is constructed using 2-inch tubing placed level along the profile (not on channel grade). The scenario envisions that the culvert and roadway have been overtopped through the flood and the roadway scoured to an elevation of the invert of the culvert. Upstream and downstream headwalls (if any) have been failed. The culvert is perched at the outlet. The intent here is to have participants recognize that the structure is undersized and not on channel grade and replace it with an appropriately sized structure that meets standards.

- 5: Headcut: This headcut threatens the upstream culvert and banks. Participants may use a number of techniques to stabilize it.
- 6: Incision triggered embankment failure: This embankment failure is the result of channel incision which is marked on the upstream end by the upstream headcut. The incision has resulted in an embankment that is higher than pre-flood embankment and participants will have to select a practice that minimizes encroachment on the river channel.

- 7: Nickpoint and wood debris accumulation: This headcut represents the upstream end of an incision process that extends downstream to section GG'. Woody debris has accumulated and lodged immediately downstream of the nickpoint.

- 8: Incision triggered embankment failure: This embankment failure was caused by the channel incision process that extended upstream to the upstream nickpoint. The challenge for participants is to rebuild an embankment that is stable but doesn't encroach into the bankfull channel.

- 9: Channel avulsion: This channel avulsion developed during the flood event. Participants should be encouraged to evaluate the stability of the avulsion channel and associated risks and benefits when determining how to manage it.

- 10: Channel spanning woody debris jam and upstream channel filling aggradation: This severe debris jam was likely initiated by the shallow channel that resulted from deposition related to the upstream incision and embankment failure. The deposition and jam appear to be responsible for diverting flow into the outside bank and causing the bank failure.

- 11: Lateral channel migration: This bank failure was likely the result of flows being diverted from the upstream woody debris jam into the bank. Participants should understand that the bank failure is the result of only lateral channel movement and not vertical instability. The selected management option should consider this.

- 12: Minor woody debris jam: This woody debris jam is not channel spanning and doesn't represent significant risk to infrastructure. Participants should be encouraged to give consideration to leaving the jam in place and potentially enhancing its value as a habitat feature.

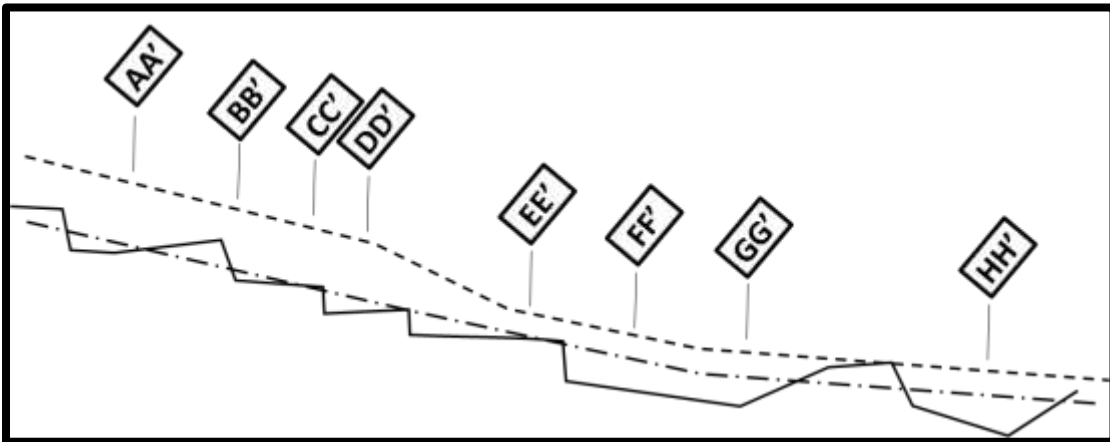
Figure 3. Profile view of the flood damaged river. Dash line represents top of bank. Dash-dot line represents equilibrium bed profile.

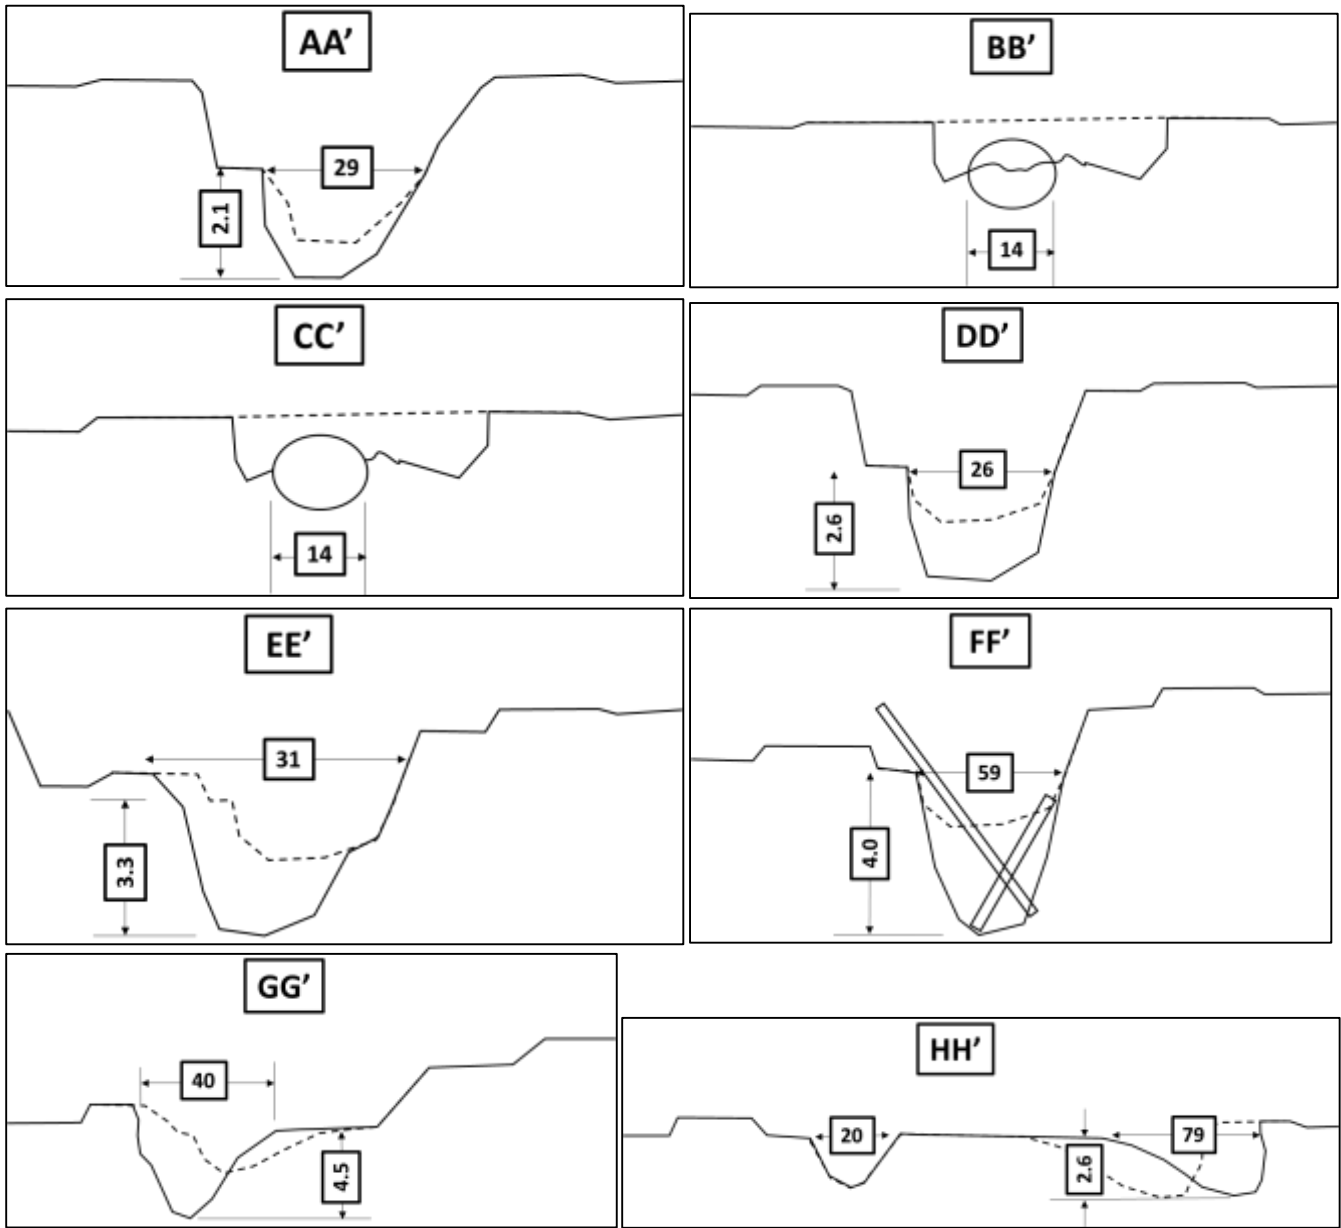
Pre and Post Flood Cross Sections

AA': This section lies in a narrow and steep valley. The natural entrenchment is increased by the roadway fills on both banks. The section downcut during the flood ($D = 2.1$ ft.) and is slightly wider than predicted ($W = 29$ ft.). Failure of the downstream step feature indicates that the incision was initiated at or below the step and migrated through this section. A nickpoint is present upstream of this section and threatens the energy dissipater.

BB': This section lies in a narrow and steep valley and at the inlet of a culvert. The natural entrenchment is increased by the approach fills on both banks. The section has completely filled with culvert induced deposition. The deposits likely originated from the upstream incised reach. Channel flow has been re-routed into the toe of the roadway on river-right.

CC': This section lies in a narrow and steep valley at the midpoint of the culvert. The natural entrenchment has been increased by the approach fills on both banks. The culvert has a diameter of (14 ft.) Severe deposition at the culvert inlet has resulted roadway overtopping and structure outflanking.

DD': This section lies in a narrow and steep valley at the midpoint of the culvert. The natural entrenchment is increased by the approach fills on both banks. The section downcut during the flood and is moderately incised ($D = 5$ ft.).

EE': This section lies in a moderately broad valley that is narrowed by the roadway on river-left. The river has historically downcut as evidenced by an abandoned terrace on river right. The active floodplain is several feet lower than abandoned terrace. The channel is severely incised ($D = 3.3$ ft.) and has widened into the roadway on river-left ($W = 31$ ft.).

FF: This section sits in a broad valley that is narrowed by the roadway on river-left. The river has historically downcut as evidenced by an abandoned terrace on river right. Current floodplain is several feet lower than abandoned terrace. The channel is severely incised with an average bankfull depth of 8.0 ft. Flood adjustments include incision and lateral migration into the road embankment.

GG': This section sits in a broad low gradient valley which has been greatly narrowed by the roadway on river-left. Aggradation initiated by the downstream woody debris jam caused lateral migration and channel incision during the flood.

HH': This section sits in a broad low gradient valley which is only minimally constricted by the roadways. The section crosses the main channel and the flood shoot.

AA: The section could be reconstructed to elevate bed to restore bankfull depth and protect energy dissipater. The downstream step feature could be restored or rebuilt.

BB: The woody debris at the culvert inlet will need to be at least partially removed. Design considerations must include floodplain morphology, bankfull channel dimensions, boundary condition and continuity with the crossing structure dimensions.

CC: The appropriate reconstruction of this section involves culvert replacement with a bankfull width structure that is on vertical and horizontal alignment, is appropriately embedded, and reconstruction of headwalls and roadway approaches. Determination of the correct vertical alignment is complicated by the fact that the channel downstream of the culvert has incised. Participants will need to determine which vertical profile (pre or post flood) to match.

DD: Reconstruction of this section should focus on raising the bed elevation to return connectivity to adjacent floodplain benches and address the nickpoints that developed during the flood. AOP must be considered in the bed elevation design. The river-right terrace could be lowered to the bankfull elevation to provide additional flood relief. However, the risk associated with increasing the frequency with which the road embankment is exposed to flood flows must be considered.

EE: This roadway must be reconstructed on the pre-flood alignment. There are several possible alternatives for the embankment design ranging from a 2:1 rip-rap embankment that does not re-establish a bankfull bench, to a stacked wall which provides enough horizontal room for creation of a floodplain bench. Reconstruction may also include lowering of the terrace on river-right to provide greater flood relief.

FF: The section could be reconstructed to include placed rip-rap wall, slight bed armoring to elevate thalweg and excavation of point bar to slide channel back to river right. Additionally the abandoned terrace could be excavated to provide flood relief. This section would ideally have much more floodplain width so the placed wall and floodplain cut are important.

GG: This section could be reconstructed by moving river-left roadway away from the river to provide overbank area. The channel avulsion could be stabilized and retained as a flood chute. The debris jams should be removed to the extent necessary to provide bankfull flow conveyance. The roadway could be restored by rebuilding the embankment at 1.5:1 and the point bar excavated to move the channel away from the roadway and re-establish a stable bankfull width.

HH': This section includes the mainstem which has migrated laterally during the flood and an avulsion chute which developed during the flood. The reconstruction could consist of rebuilding the road embankment on river left. Consideration should be given to whether the avulsion should be maintained as a flood chute or filled in.

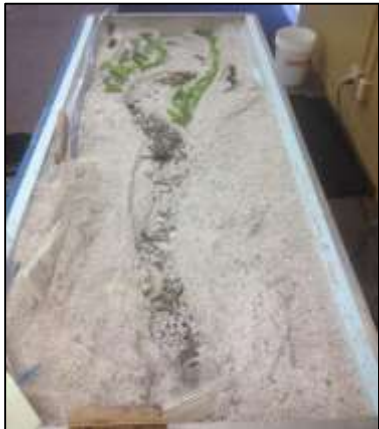
Figure 1. General valley and channel morphology set-up.

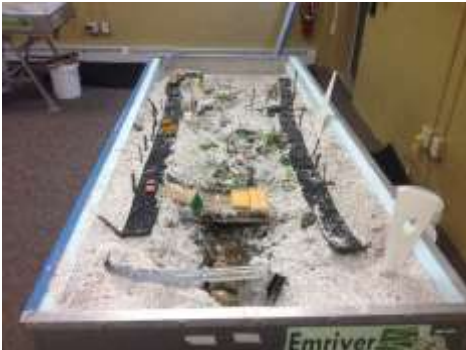
Figure 2. Participant constructed flood recovery.

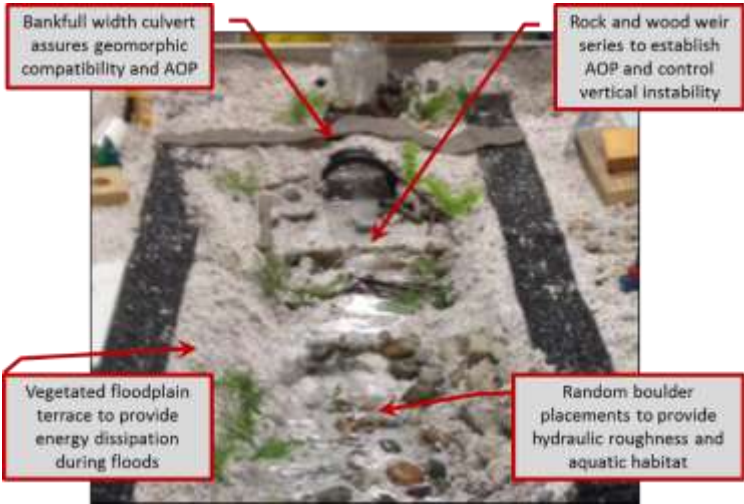
Figure 3. Example of a completed flood recovery exercise.
