Vermont Rivers and Roads Training Program

River Modeling Exercises

Appendix A: Disaster Scenario Plans Profile and Cross Sections

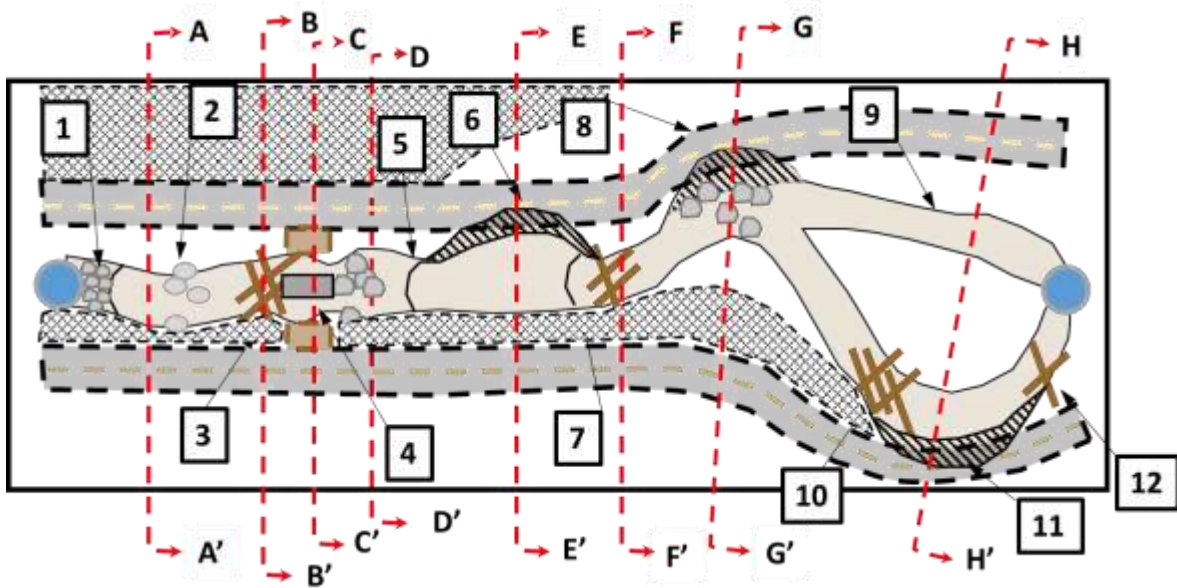
Figure 2. Planview of river model showing cross section locations and scenario features.

The 12 primary features included in the scenario are presented in figure XX. These features represent infrastructure failures and channel adjustments that must be addressed in the recovery design. These features may also provide diagnostic information that supports river process analysis and recovery design. Each feature and its construction are described below and possible solutions for addressing them are presented.

- 1: Energy Dissipater: The purpose of the energy dissipater is to prevent outfall scour and maintain the upstream grade of the channel and prevent flow from going sub-surface. It is constructed by digging a basin that is approximately 4 inches in diameter and 2 inches deep, lining it with geotextile and covering with ¼ to ½ inch stone.

- 2: Partially Failed Step Feature: The step feature is intended to indicate that the reach within the upper third of the flume is a step-pool Bedform. Participants should use the presence of the step-pool feature to support their selection of recovery practices (i.e. rock weir grade control). The step should be identified as a feature to be restored and may be used as an indication of appropriate excavation depth. Setup of the step feature is straight forward. Use a size stone that allows for 5 – 6 stones to span the bankfull channel. The step feature should be partially buried by flood deposits during setup to provide a reminder to participants that deposition excavation should be done carefully so as not to disturb boundary features that remained intact through the flood.

- 3: Aggraded bedload and woody debris clogging culvert: Participants will recognize that the deposited bedload and woody debris should be removed during the recovery operation. Discuss the appropriate width and depth to which the channel should be dredged before the material is excavated. A bankfull bench at this section provides a benchmark for measuring appropriate channel dimensions.

- 4: Undersized Culvert: The culvert is constructed using 2-inch tubing placed level along the profile (not on channel grade). The scenario envisions that the culvert and roadway have been overtopped through the flood and the roadway scoured to an elevation of the invert of the culvert. Upstream and downstream headwalls (if any) have been failed. The culvert is perched at the outlet. The intent here is to have participants recognize that the structure is undersized and not on channel grade and replace it with an appropriately sized structure that meets standards.

- 5: Headcut: This headcut threatens the upstream culvert and banks. Participants may use a number of techniques to stabilize it.
- 6: Incision triggered embankment failure: This embankment failure is the result of channel incision which is marked on the upstream end by the upstream headcut. The incision has resulted in an embankment that is higher than pre-flood embankment and participants will have to select a practice that minimizes encroachment on the river channel.

- 7: Nickpoint and wood debris accumulation: This headcut represents the upstream end of an incision process that extends downstream to section GG'. Woody debris has accumulated and lodged immediately downstream of the nickpoint.

- 8: Incision triggered embankment failure: This embankment failure was caused by the channel incision process that extended upstream to the upstream nickpoint. The challenge for participants is to rebuild an embankment that is stable but doesn't encroach into the bankfull channel.

- 9: Channel avulsion: This channel avulsion developed during the flood event. Participants should be encouraged to evaluate the stability of the avulsion channel and associated risks and benefits when determining how to manage it.

- 10: Channel spanning woody debris jam and upstream channel filling aggradation: This severe debris jam was likely initiated by the shallow channel that resulted from deposition related to the upstream incision and embankment failure. The deposition and jam appear to be responsible for diverting flow into the outside bank and causing the bank failure.

- 11: Lateral channel migration: This bank failure was likely the result of flows being diverted from the upstream woody debris jam into the bank. Participants should understand that the bank failure is the result of only lateral channel movement and not vertical instability. The selected management option should consider this.

- 12: Minor woody debris jam: This woody debris jam is not channel spanning and doesn't represent significant risk to infrastructure. Participants should be encouraged to give consideration to leaving the jam in place and potentially enhancing its value as a habitat feature.

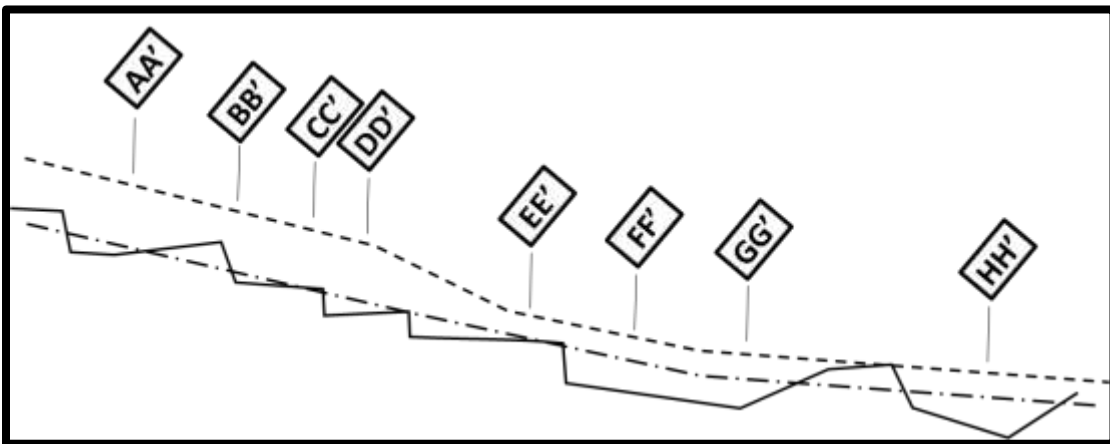
Figure 3. Profile view of the flood damaged river. Dash line represents top of bank. Dash-dot line represents equilibrium bed profile.

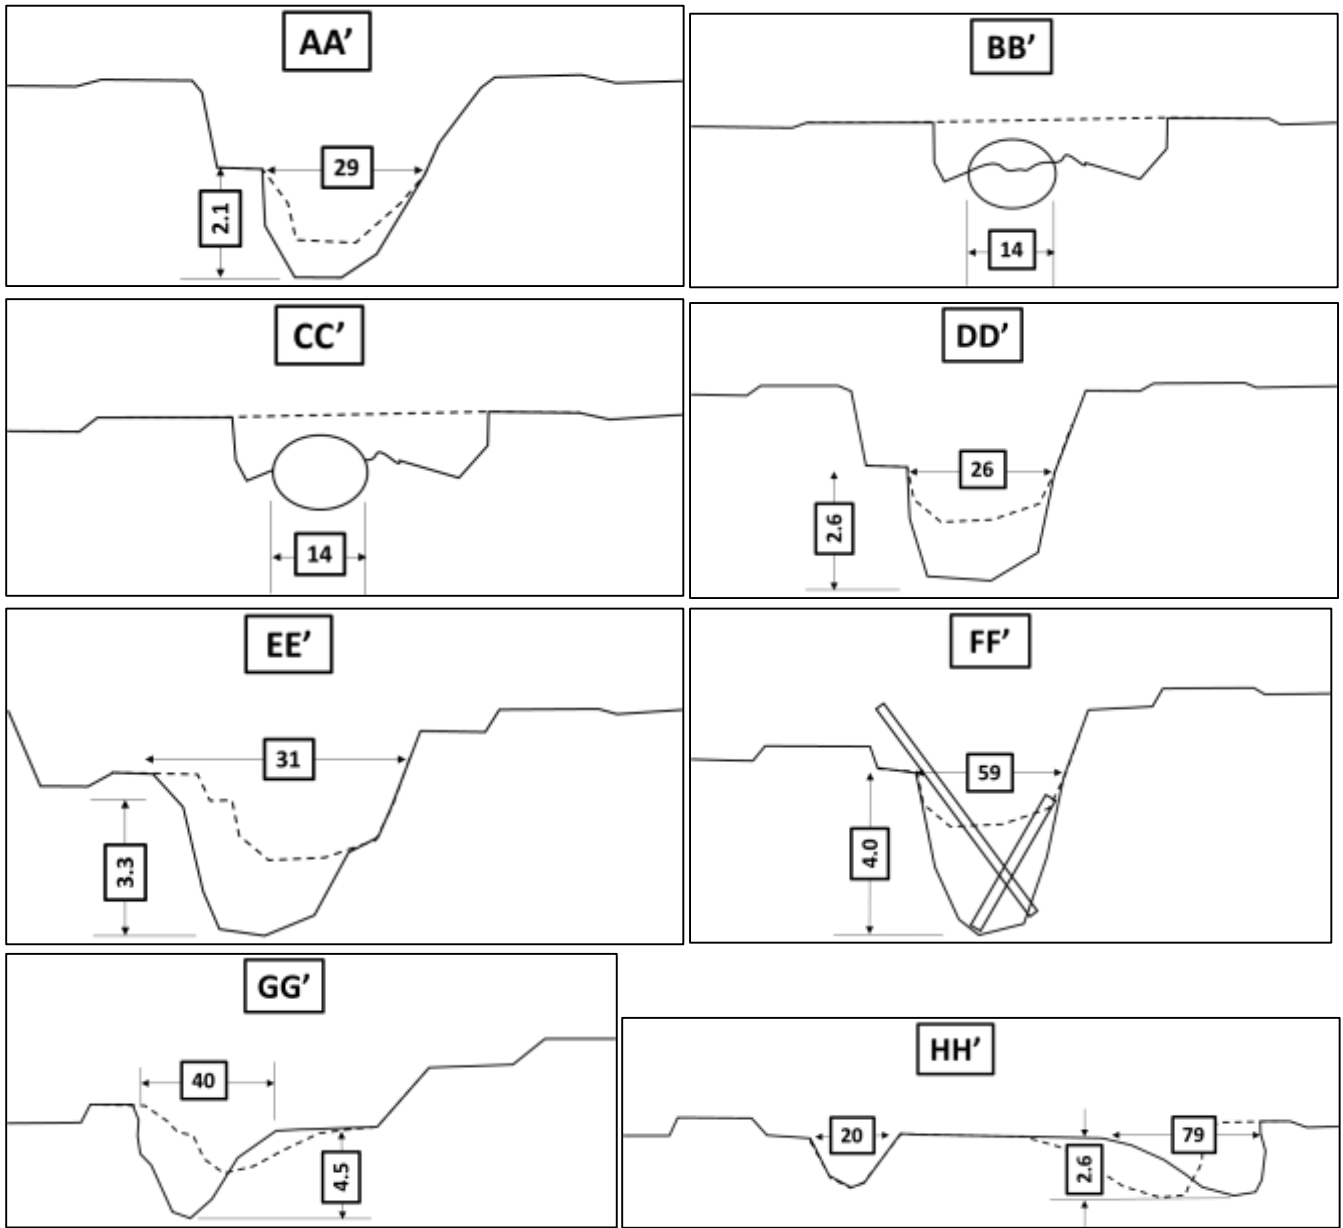
Pre and Post Flood Cross Sections

AA': This section lies in a narrow and steep valley. The natural entrenchment is increased by the roadway fills on both banks. The section downcut during the flood ($D = 2.1$ ft.) and is slightly wider than predicted ($W = 29$ ft.). Failure of the downstream step feature indicates that the incision was initiated at or below the step and migrated through this section. A nickpoint is present upstream of this section and threatens the energy dissipater.

BB': This section lies in a narrow and steep valley and at the inlet of a culvert. The natural entrenchment is increased by the approach fills on both banks. The section has completely filled with culvert induced deposition. The deposits likely originated from the upstream incised reach. Channel flow has been re-routed into the toe of the roadway on river-right.

CC': This section lies in a narrow and steep valley at the midpoint of the culvert. The natural entrenchment has been increased by the approach fills on both banks. The culvert has a diameter of (14 ft.) Severe deposition at the culvert inlet has resulted roadway overtopping and structure outflanking.

DD': This section lies in a narrow and steep valley at the midpoint of the culvert. The natural entrenchment is increased by the approach fills on both banks. The section downcut during the flood and is moderately incised ($D = 5$ ft.).

EE': This section lies in a moderately broad valley that is narrowed by the roadway on river-left. The river has historically downcut as evidenced by an abandoned terrace on river right. The active floodplain is several feet lower than abandoned terrace. The channel is severely incised ($D = 3.3$ ft.) and has widened into the roadway on river-left ($W = 31$ ft.).

FF: This section sits in a broad valley that is narrowed by the roadway on river-left. The river has historically downcut as evidenced by an abandoned terrace on river right. Current floodplain is several feet lower than abandoned terrace. The channel is severely incised with an average bankfull depth of 8.0 ft. Flood adjustments include incision and lateral migration into the road embankment.

GG': This section sits in a broad low gradient valley which has been greatly narrowed by the roadway on river-left. Aggradation initiated by the downstream woody debris jam caused lateral migration and channel incision during the flood.

HH': This section sits in a broad low gradient valley which is only minimally constricted by the roadways. The section crosses the main channel and the flood shoot.

AA: The section could be reconstructed to elevate bed to restore bankfull depth and protect energy dissipater. The downstream step feature could be restored or rebuilt.

BB: The woody debris at the culvert inlet will need to be at least partially removed. Design considerations must include floodplain morphology, bankfull channel dimensions, boundary condition and continuity with the crossing structure dimensions.

CC: The appropriate reconstruction of this section involves culvert replacement with a bankfull width structure that is on vertical and horizontal alignment, is appropriately embedded, and reconstruction of headwalls and roadway approaches. Determination of the correct vertical alignment is complicated by the fact that the channel downstream of the culvert has incised. Participants will need to determine which vertical profile (pre or post flood) to match.

DD: Reconstruction of this section should focus on raising the bed elevation to return connectivity to adjacent floodplain benches and address the nickpoints that developed during the flood. AOP must be considered in the bed elevation design. The river-right terrace could be lowered to the bankfull elevation to provide additional flood relief. However, the risk associated with increasing the frequency with which the road embankment is exposed to flood flows must be considered.

EE: This roadway must be reconstructed on the pre-flood alignment. There are several possible alternatives for the embankment design ranging from a 2:1 rip-rap embankment that does not re-establish a bankfull bench, to a stacked wall which provides enough horizontal room for creation of a floodplain bench. Reconstruction may also include lowering of the terrace on river-right to provide greater flood relief.

FF: The section could be reconstructed to include placed rip-rap wall, slight bed armoring to elevate thalweg and excavation of point bar to slide channel back to river right. Additionally the abandoned terrace could be excavated to provide flood relief. This section would ideally have much more floodplain width so the placed wall and floodplain cut are important.

GG: This section could be reconstructed by moving river-left roadway away from the river to provide overbank area. The channel avulsion could be stabilized and retained as a flood chute. The debris jams should be removed to the extent necessary to provide bankfull flow conveyance. The roadway could be restored by rebuilding the embankment at 1.5:1 and the point bar excavated to move the channel away from the roadway and re-establish a stable bankfull width.

HH': This section includes the mainstem which has migrated laterally during the flood and an avulsion chute which developed during the flood. The reconstruction could consist of rebuilding the road embankment on river left. Consideration should be given to whether the avulsion should be maintained as a flood chute or filled in.

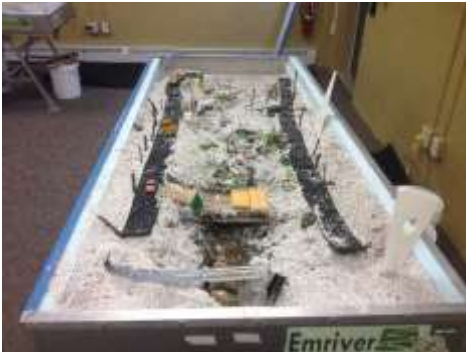
Figure 2. Participant constructed flood recovery.
