Vermont Rivers and Roads Training Program

River Modeling Exercises

Appendix A: Disaster Scenario Plans Profile and Cross Sections

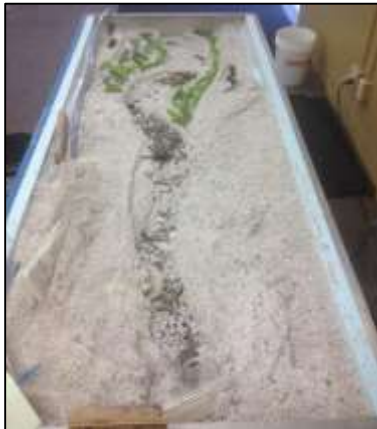
Figure 1. General valley and channel morphology set-up.

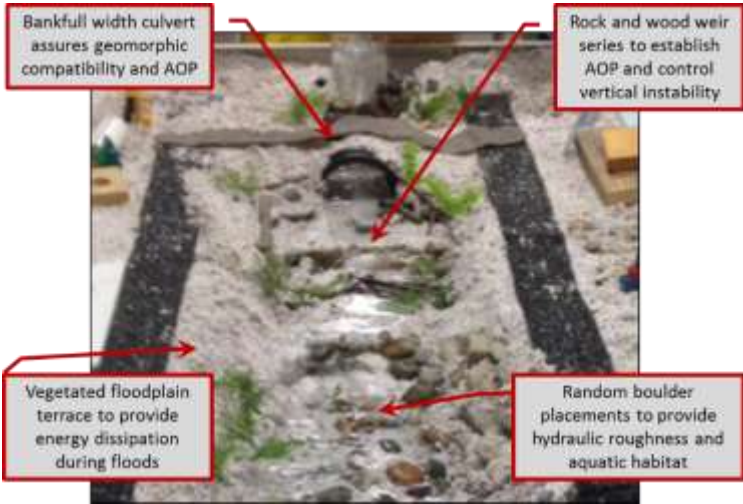
Figure 3. Example of a completed flood recovery exercise.
